Aboriginal Due Diligence  
Assessment Report

### **NARROMINE FREIGHT HUB**

NARROMINE, NSW

MAY 2023

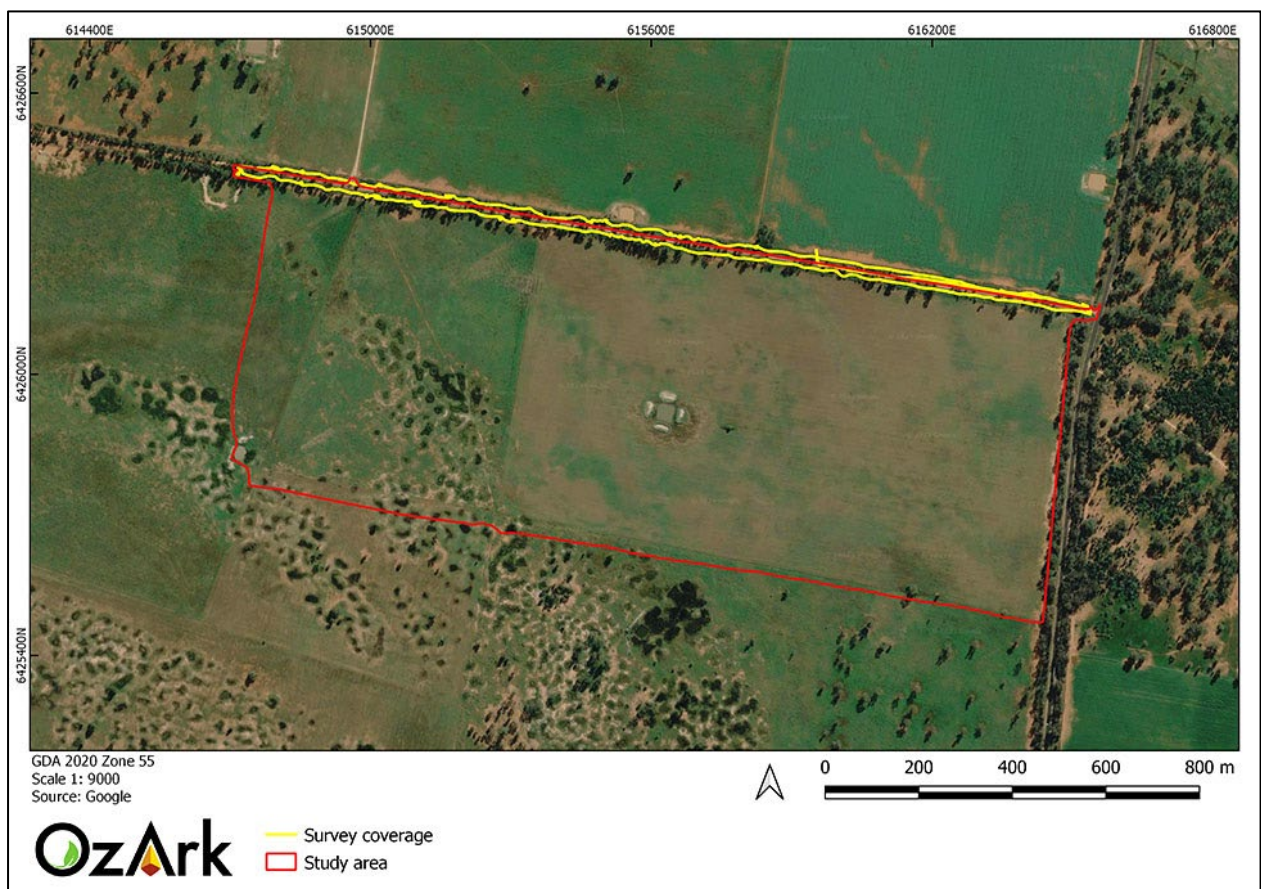
**Figure 2-5: Survey coverage along the northern boundary of the study area.**

The visual inspection of the northern boundary of the study area was undertaken by OzArk Archaeologist, Imogen Crome, on 26 April 2023.

The visual inspection did not record any Aboriginal sites or landforms with subsurface archaeological potential. The lack of archaeological potential is based on the undifferentiated nature of the landform and lack of resources (i.e. water) which would have attracted occupation by Aboriginal people.

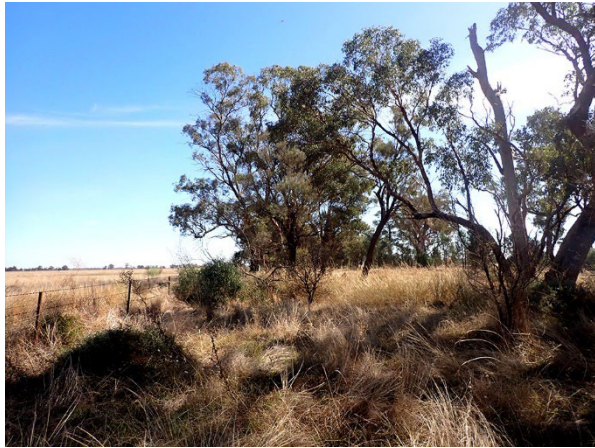
The study area was confirmed as consisting of flat plains landform with remnant mature vegetation (**Plate 1** and **Plate 2**).

Plate 1: View west across the southern corridor of Craigie Lea Lane.

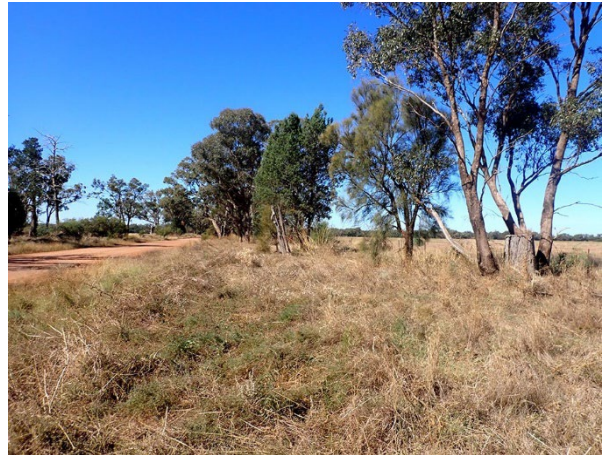
Plate 2: View east along the southern corridor of Craigie Lea Lane.

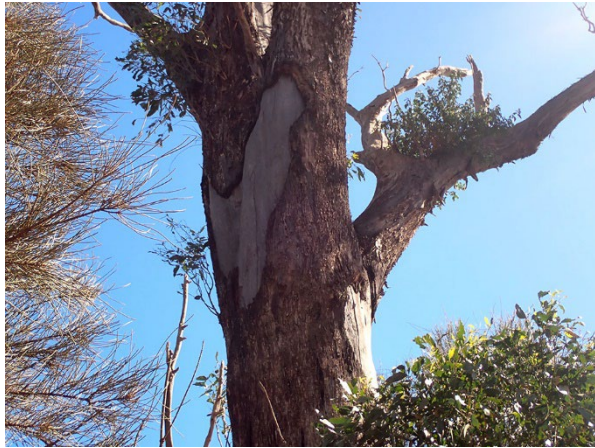
Species of grey and Bimble box remain within the road corridor at the northern end of the study area. Many of these trees have been scarred by naturally occurring processes, however no vegetation displayed comprehensive signs of cultural modification (**Plate 3**).

Plate 3: View of natural scarring on mature native vegetation (likely caused by birds).

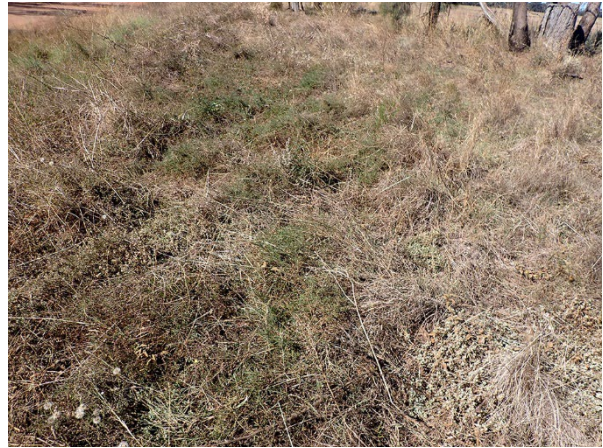
Plate 4: View of low GSV within the study area.
